Sept. 27, 2010

RE: Sammamish River Weir Visit

Following, you will find several topics with photos describing the situation at the weir and in the Transition Zone (TZ) which were of special focus during the site visit and actions to take as a result. In Appendix A, I have included a summary of the first meeting we had on August 19th. Appendix B provides a summary of a subsequent meeting citizens had with the Corps of Engineers.

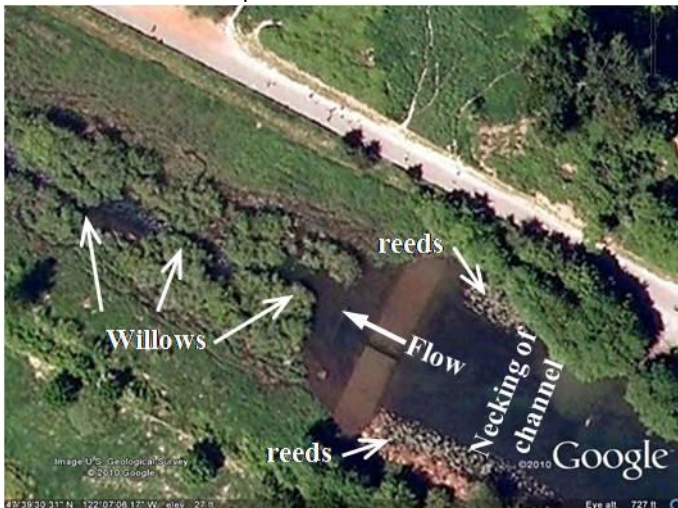
Recent Aerial Photo at Weir Showing Willow Overgrowth and Upstream Constraints

As you'll recall from our field visit, the center (or low-flow channel, as it is known) was heavily overgrown. One individual in the group estimated that the frontage of willows, when looking downstream from the weir, is now over 80 ft wide! Research by our lake residents group has determined that a 1993 transition zone brushing agreement allowed two 10 ft wide willow buffers to border each side of the low-flow center channel. However, this was predicated on the assumption that the remaining transition zone area would be fully effective and sufficiently capable of conveying designed flood flow rates. It was obvious from the site visit - that assumption has been compromised.

- 1) Remove all snags, debris, logs, etc. as they are obstructing the free flow in the center channel.
- 2) Trim up the willows 8-12 feet from their base to create an open flow "window". Creating this flow "window" will, in the short term - a) avoid debris accumulating among the willows, b) minimize snag formation, and c) result in a safer passage for small craft which periodically navigate the transition zone.

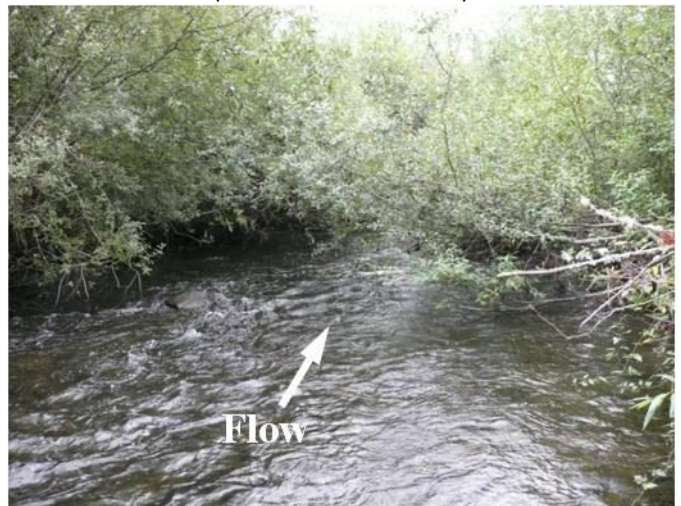
Low Flow Channel Willow Overgrowth At Weir (Site Visit Photo 9-9-10)

The center channel and willow buffer was infiltrated with snags and debris, creating stagnant pooling of water and diverting flow from what seemed to have once been part of the low-flow channel. It was observed that the water flowing at this time of year, through the center channel, passes under low lying willow branches, but that those branches would be in the flow stream at higher water levels. It seemed inconceivable that what is supposed to be a navigable channel for small craft could be navigated at all, under current degraded conditions. The willow branches and debris not only noticeably obstruct flow but are obviously a hazard to boaters attempting to navigate the transition zone, as has already been reported by the County Sheriff's Marine division.

Finally, inspection of the "resting pool" just over the weir on the downstream side revealed one or more submerged, large logs. In addition to obstructing flow, these logs will harbor predator fish, providing excellent habitat for them to "sit-in-wait" for juvenile salmon as they migrate out through the channel in the early spring.

- 3) Return the center channel to a navigable waterway. In the interim, post signage upstream (toward the lake) forewarning boaters of possible navigation constraints.

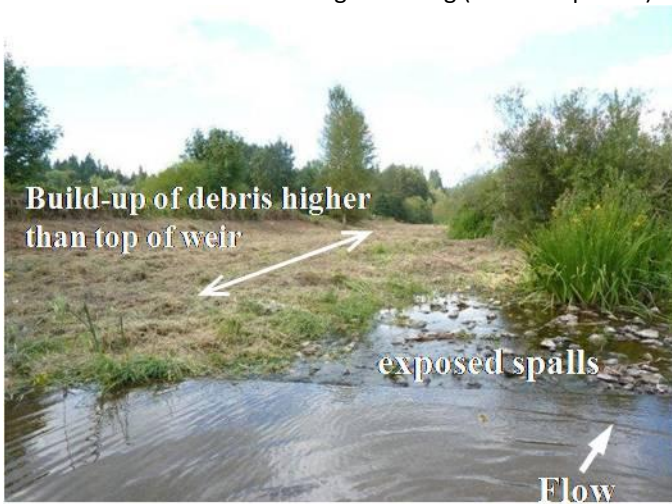
Observations - The southwest (left) channel of the Transition Zone, which flanks the low-flow center channel, was brushed (i.e., trimmed) in late August. However, during our site visit, one of the County technical staff noted that, in the past, flow data showed no discernable improvement following brushing of the left channel. This seems logical, given the accumulation of 12 to 18 inches of debris and sediment which has built-up above the quarry spall riverbed, raising the left channel elevation to a level well above that of the weir. This build-up of clippings and sediment explains why past brushing of the left channel

Southwest Channel Following Trimming (From Atop Weir)

- 1) The cuttings, which were allowed to remain after brushing, should be removed as soon as possible while water levels are relatively low.
- 2) Accumulated debris, clippings (duff), and sediment need to be removed down to the quarry spall riverbed base in order to return the channel to its original design condition. Failure to remove this build-up will merely perpetuate the ongoing ineffectiveness of most of the Transition Zone area by restricting water outflow leading to high water levels in the lake, property loss, and unnecessary pollution (see photos in Appendix A).

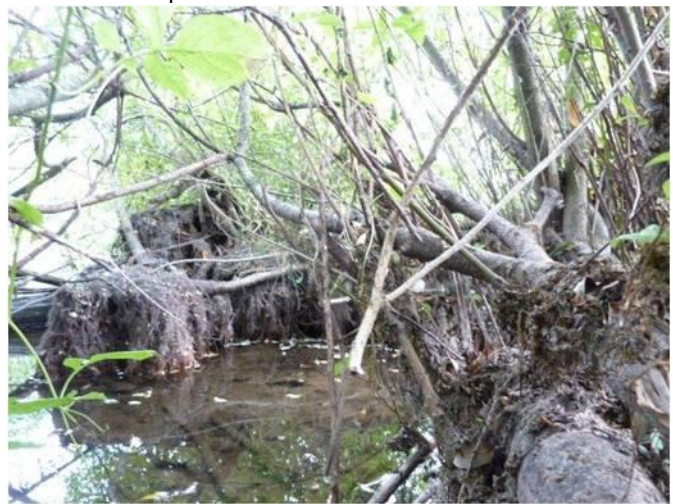
showed no flow improvement; the channel's sediment build-up is acting like a riverbank rather than a riverbed, constricting and funneling the flow towards the center channel rather than allowing water to spread-out over the full width of the left channel.

Close Up of Debris & Silt in Southwest Channel

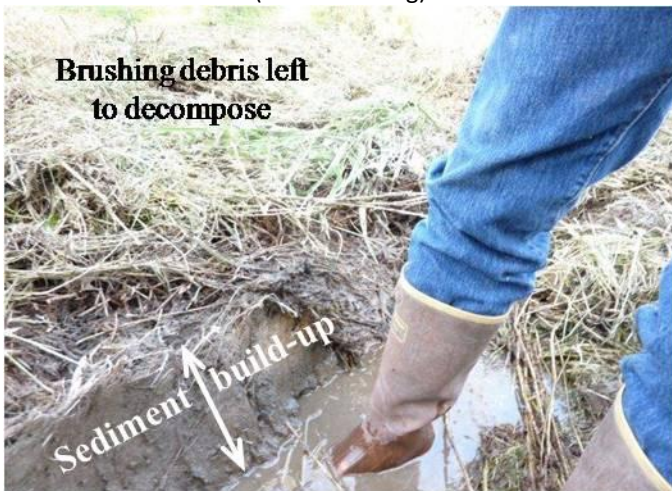
Sediment Build-up In Southwest Channel – 9/2010 (Post Trimming)

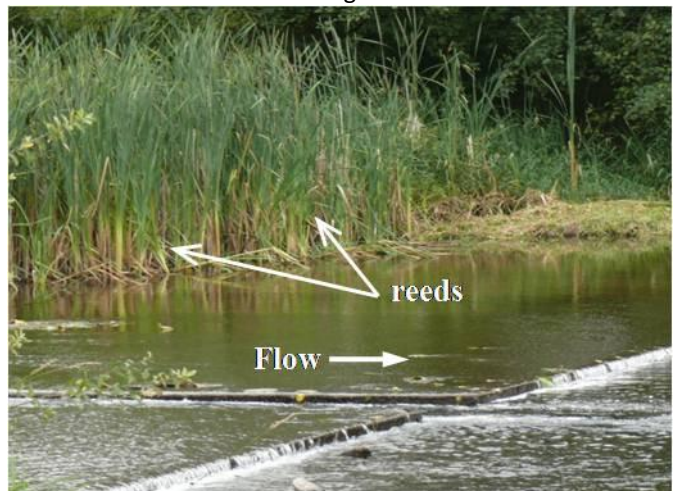
View Across Weir (southerly) Showing Obstructing Reeds Blocking Flow

- 3) The reeds ahead of the weir, as well as other vegetative restrictions along the river banks, all the way back to the lake, which are reducing the effective width of the upstream river channel, should be planned for removal next season.

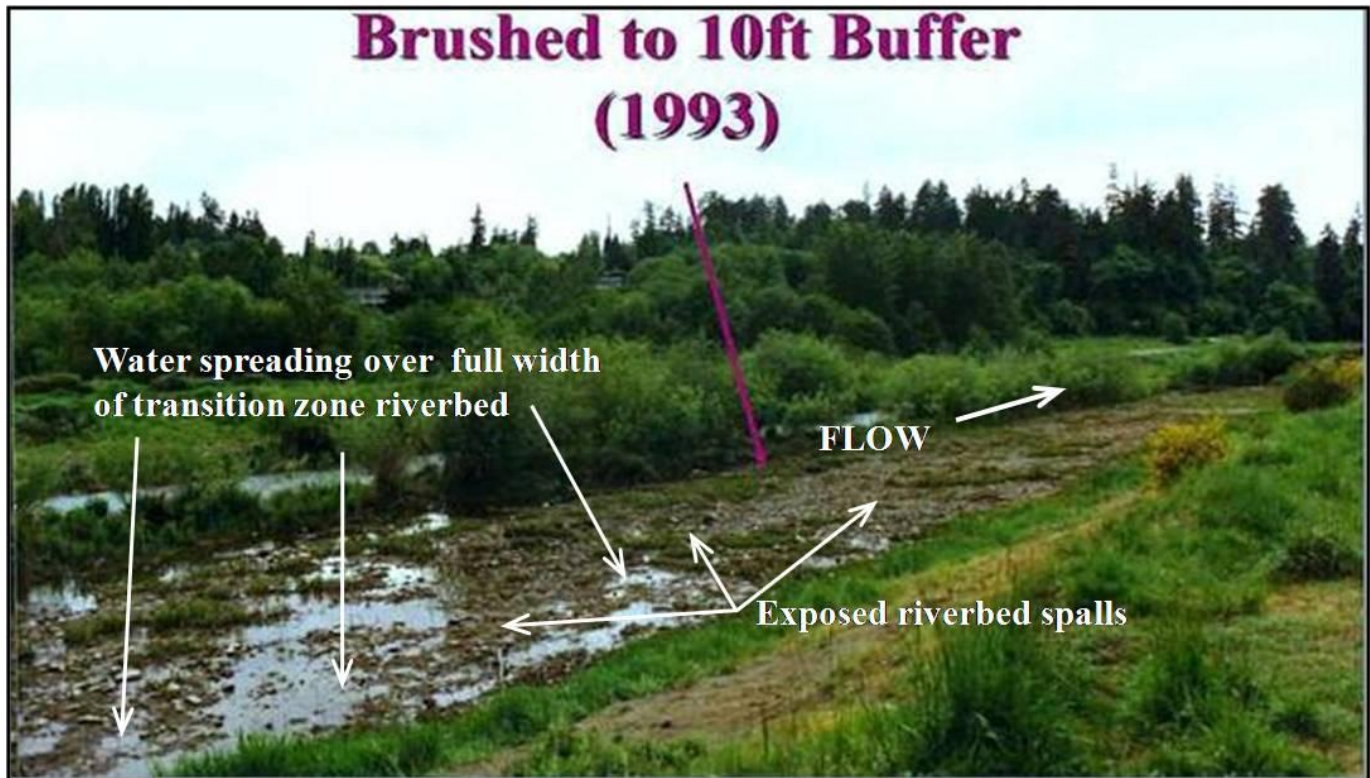
As you may recall, during the site visit I handed-out a 1993 picture of the post-brushing condition of the northeast (right) channel for attendees to compare against the conditions we were observing that day. Most noticeable from the 1993 picture were: 1) the willows were cut to a to a hedge-like edge, 2) the center channel was open and freely flowing in the background, 3) the northeast channel's quarry spalls were exposed (not covered in sediment), and 4) water is spreading and seeping over the full width of the recently cleared channel. The 1993 picture (included below) showed what the TZ condition ought to have looked like in the cleared, left channel during our visit on September 9. I think everyone who attended would agree, what we saw was not reflective of the 1993 brushed condition.

1993 Brushed Northeast Channel

- 4) As observed by WLRD director, Mark Issacson, trimming should be returned to an annual basis, both sides being brushed each and every year. The citizens readily concurred with that suggestion. King

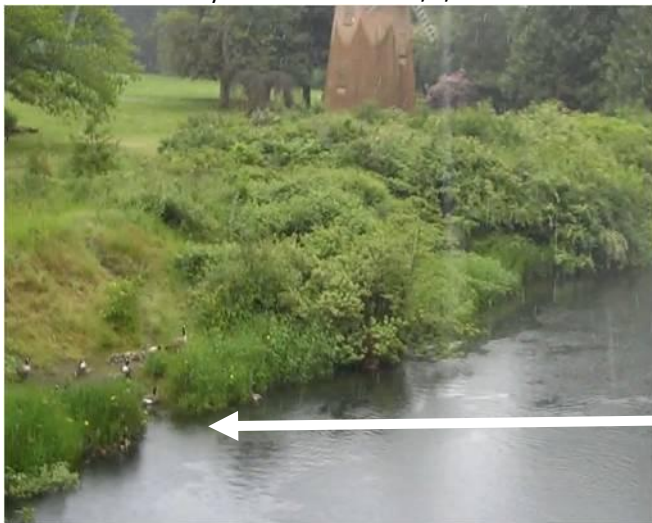
First, as shown in the photos below, the river stages at the entrance to Marymoor Park don't reflect a 7 ft rise when comparing last spring's rainy high water period to a photo of the same location in late summer.

Marymoor Entrance – 6/2/2010

Note that flow in June was only 2 to 3 feet above elevations witnessed at the summer low.

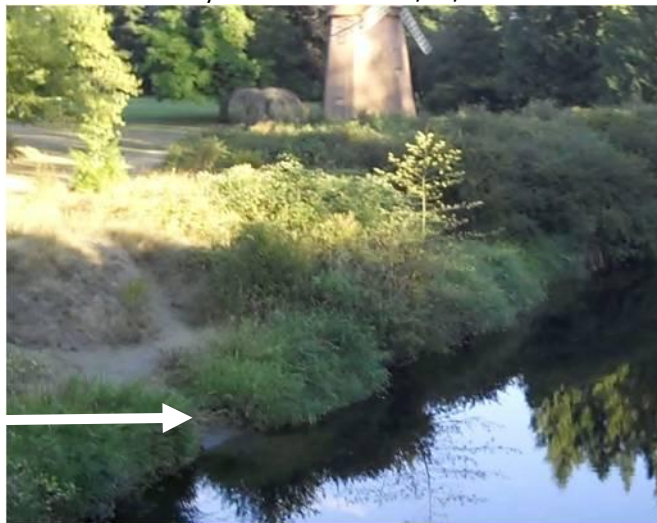
Marymoor Entrance – 8/27/2010

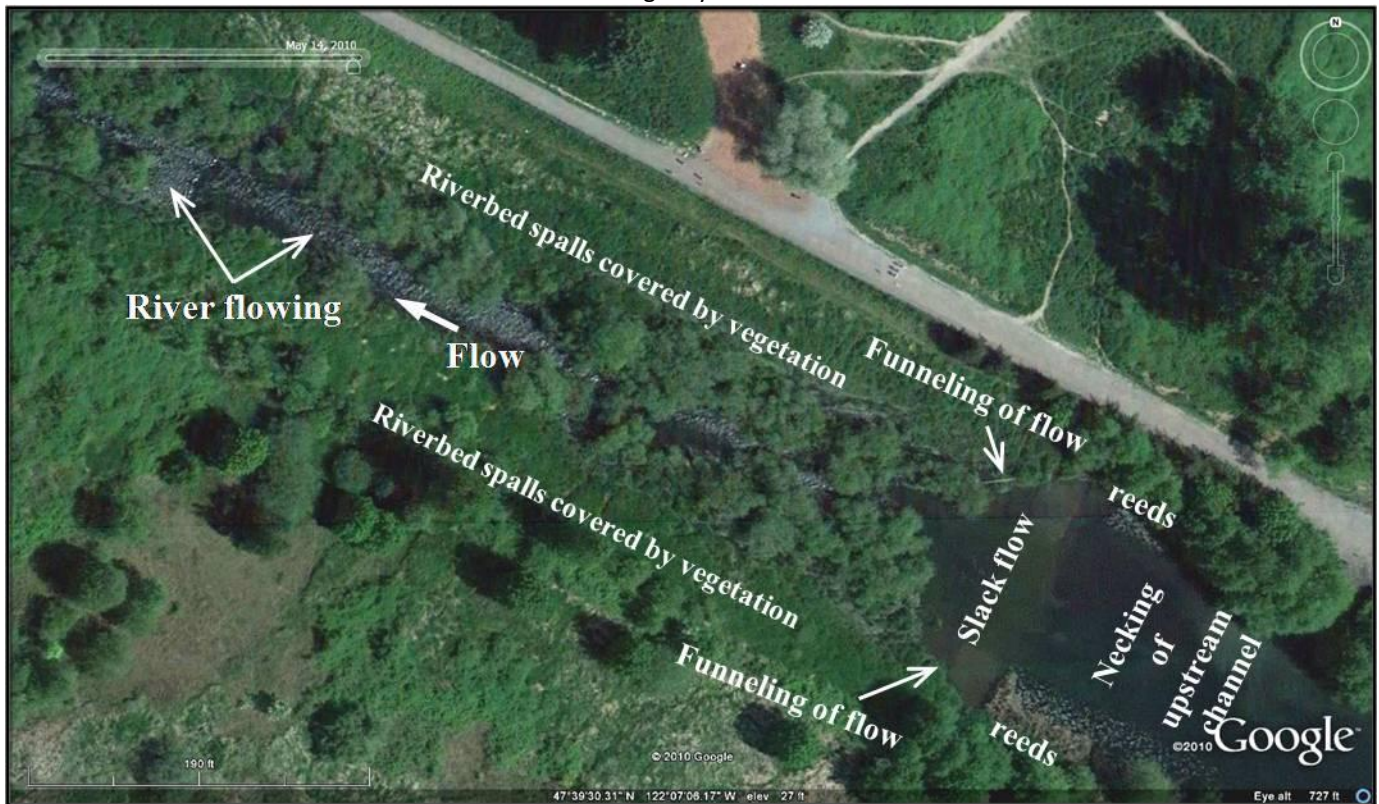
Second, free flowing water can be seen downstream of the transition zone (see left photo above) and in the middle of the TZ last spring (see photo below). Constricted, “slack” flow would indicate a backup caused by a downstream blockage or impedance, which is not evident at these two locations. There is no evidence that Bear Creek is or was, in anyway, affecting water flow out of Lake Sammamish this past spring. However, slack flow was witnessed at the weir during the late spring high water event, indicating that the immediate downstream conditions (the willows and blocked channels) were indeed restricting the free flow (see photo below).

Aerial Photo Showing May 2010 Flow Conditions

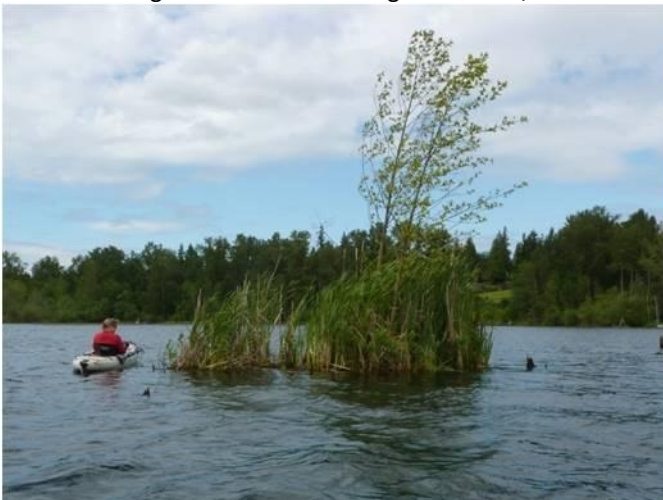
Dislodged Shoreline Polluting Lk Samm 6/2010

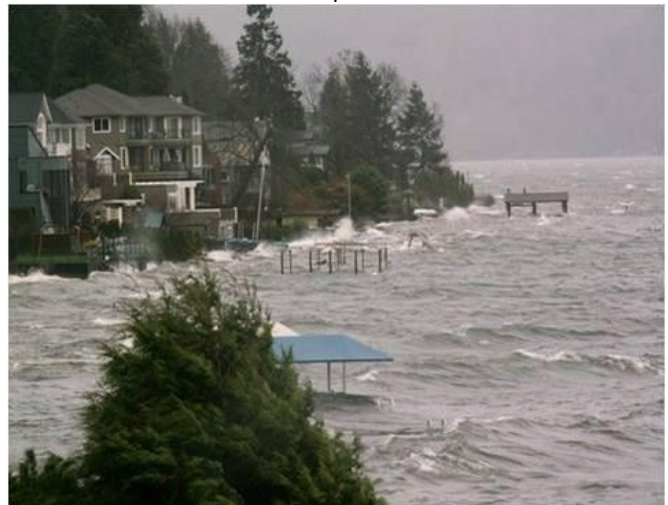
Lk Samm Storm Impacts – Winter 2006

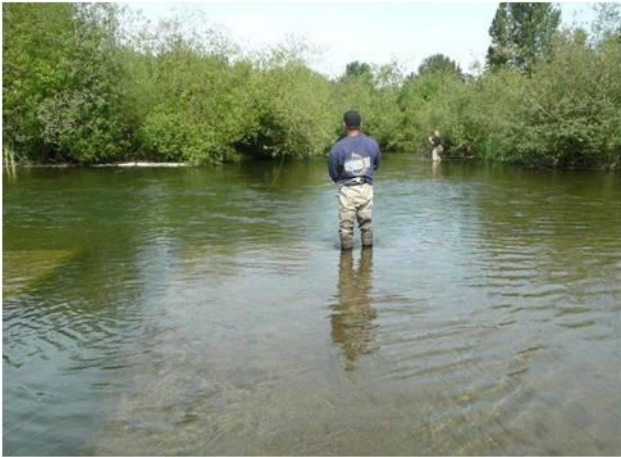
Bass Fishermen atop Weir May 2009

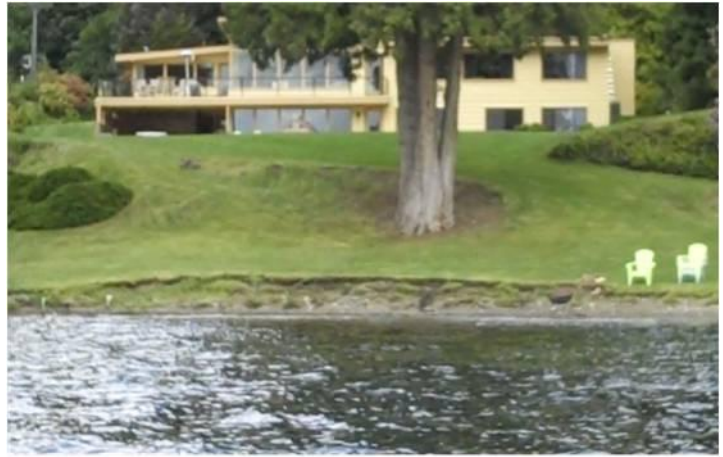
Erosive Effects of High Water – Lk Samm 2010

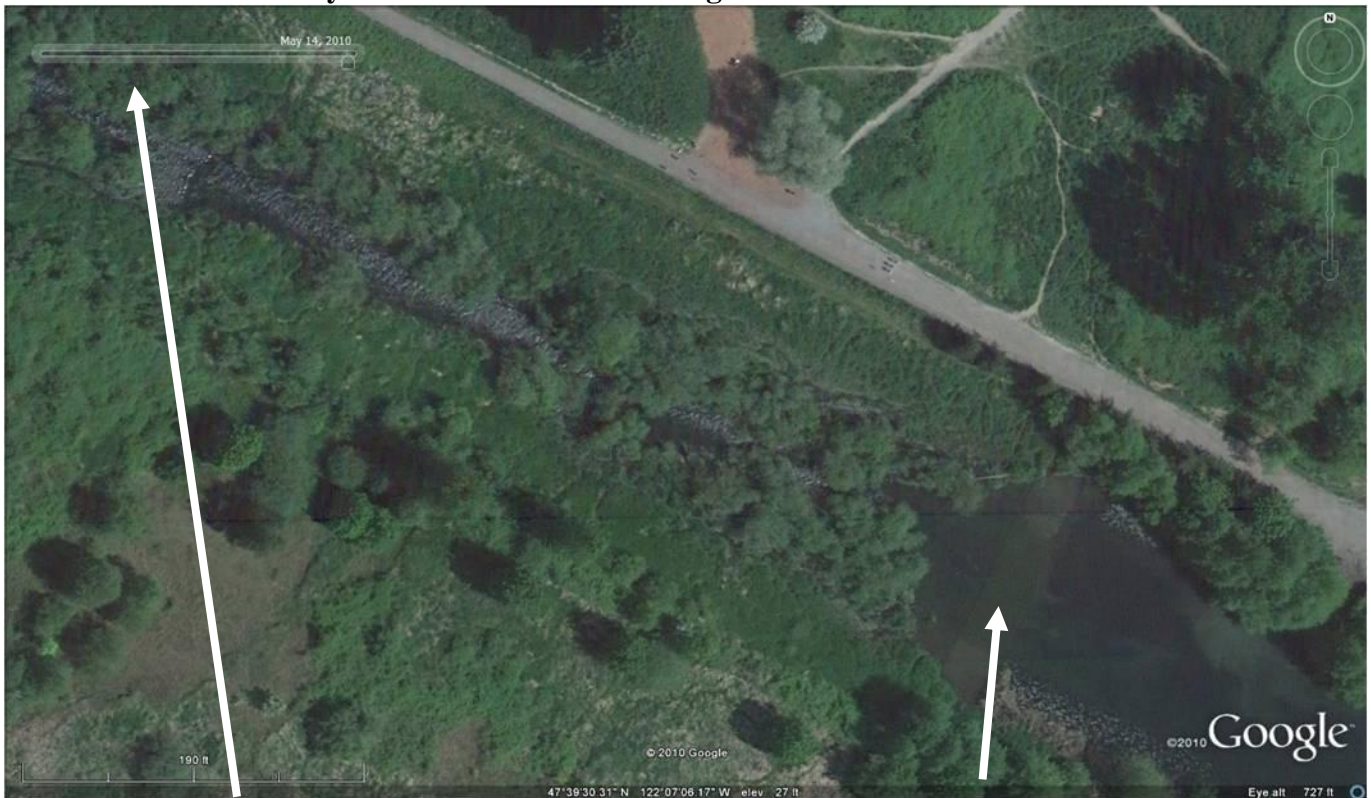
One other observation we'd like to note, to see if you concur. In the photo inserted below, from May 2010, when we know high flows were occurring, it appears that conditions have changed over time in another way. All flows seem to funnel toward the low flow channel, even at the north end of the of the transition zone heading toward Bear Creek. Is it not also important to assure the side channels are cleared all the way to that point, or is that what you were suggesting the clearing was for, toward Bear Creek, above?

May 2006 Aerial Photo Showing Transition Zone and Weir

Shrub & Tree Overgrowth Below TZ Affecting Downstream Flow
