## Field Review of Sammamish River Weir & Transition Zone – September 2011

Martin Nizlek, Ph.D. Civil Eng.

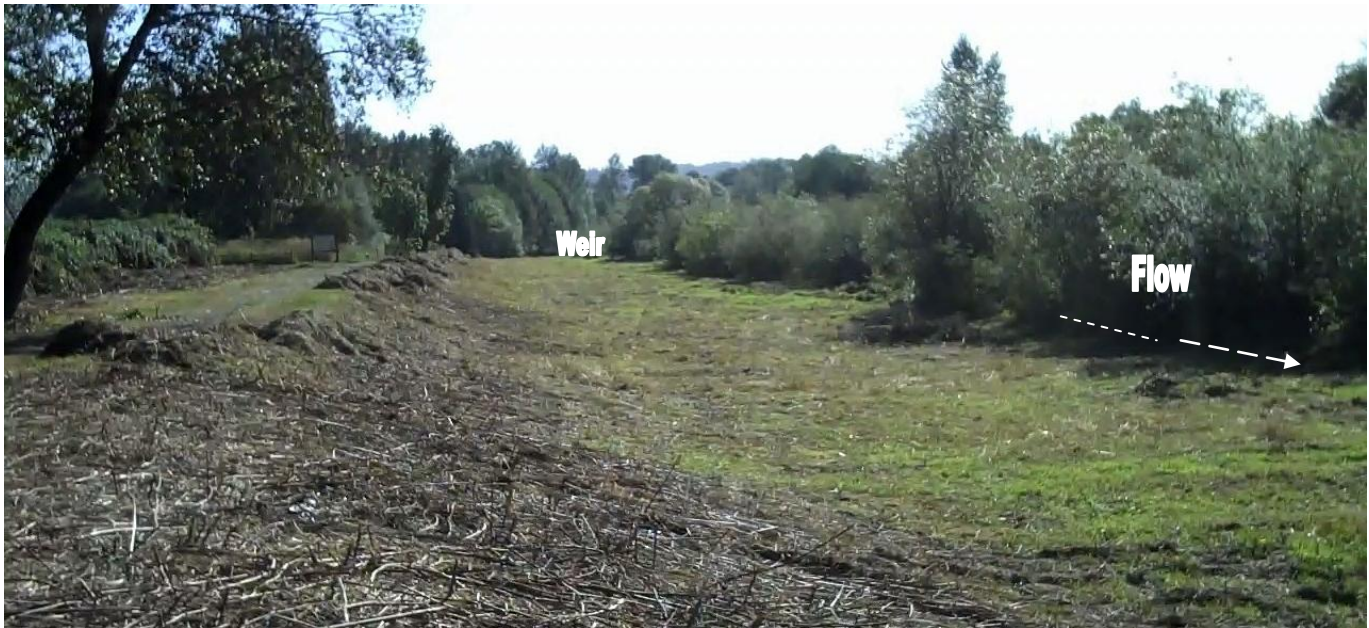
**East Channel Looking South near Terminus of TZ – Sept. 28<sup>th</sup>, 2011**  
(Showing result of channel clearing)

It was apparent that the near (east-side) channel had been cleared of trimmings from the channel proper and that larger willow stems had also been removed. The far channel could be observed on the opposite (west) side, to be similarly cleared. Neither of these outside channels carried flow at this time.

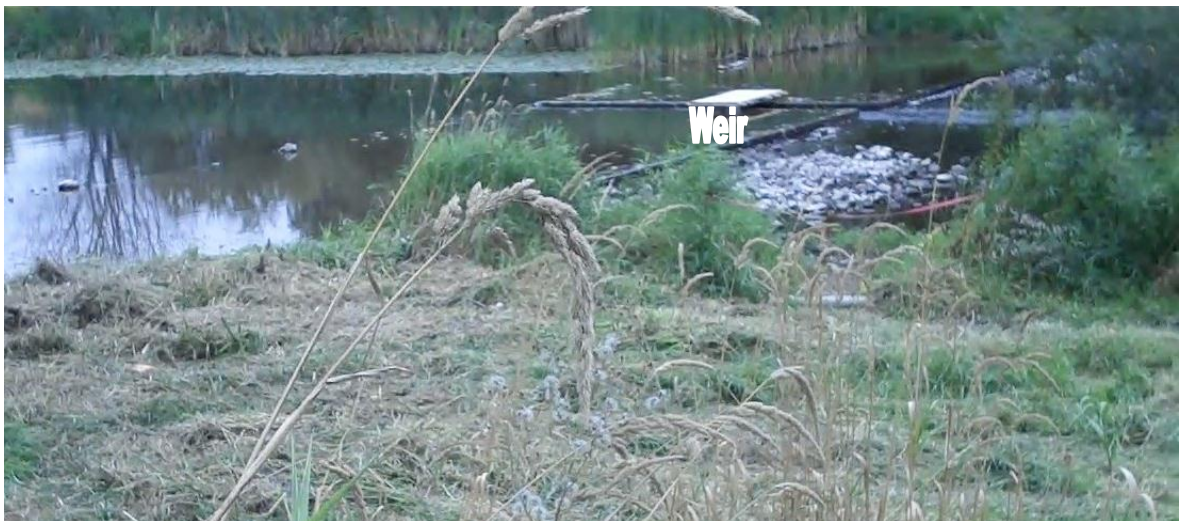
The weir proper, shown below, was slightly submerged. The area below the weir was pooled and it could be noted that the main channel heights were still distinctly higher than the top of the weir as observed in Sept. of 2010.

**Sammamish River Weir Looking West – Sept. 14, 2011**

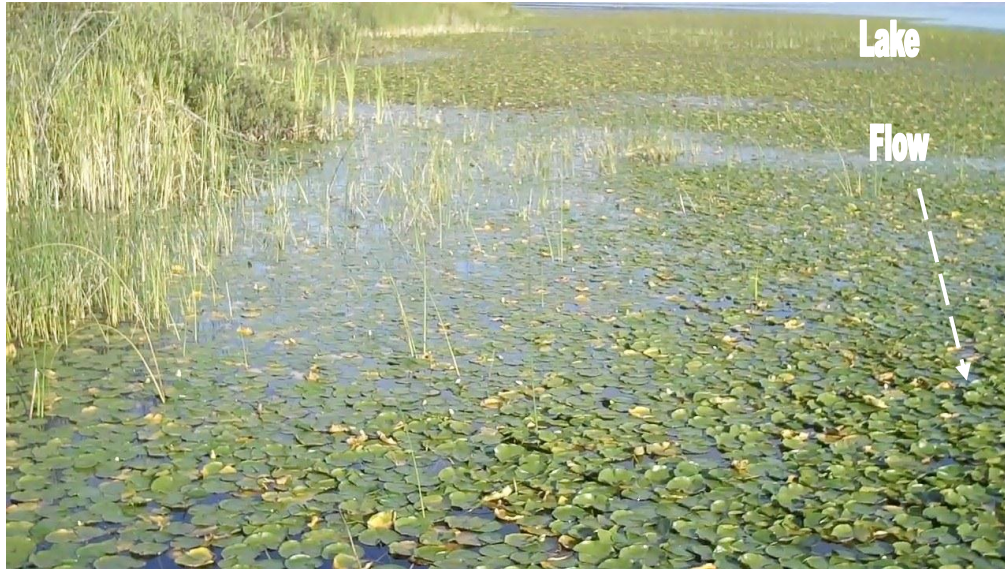
The area ahead of the weir is important to its ability to pass design level flow. Constraints to flow were observed ahead of the weir including channel narrowing due to reeds, lily pads, tree growth, and woody debris. The following photo was taken approximately 0.5 miles from the weir toward Lake Sammamish.

#### **Sammamish River Headwaters at Lake Sammamish – Sept. 2011**

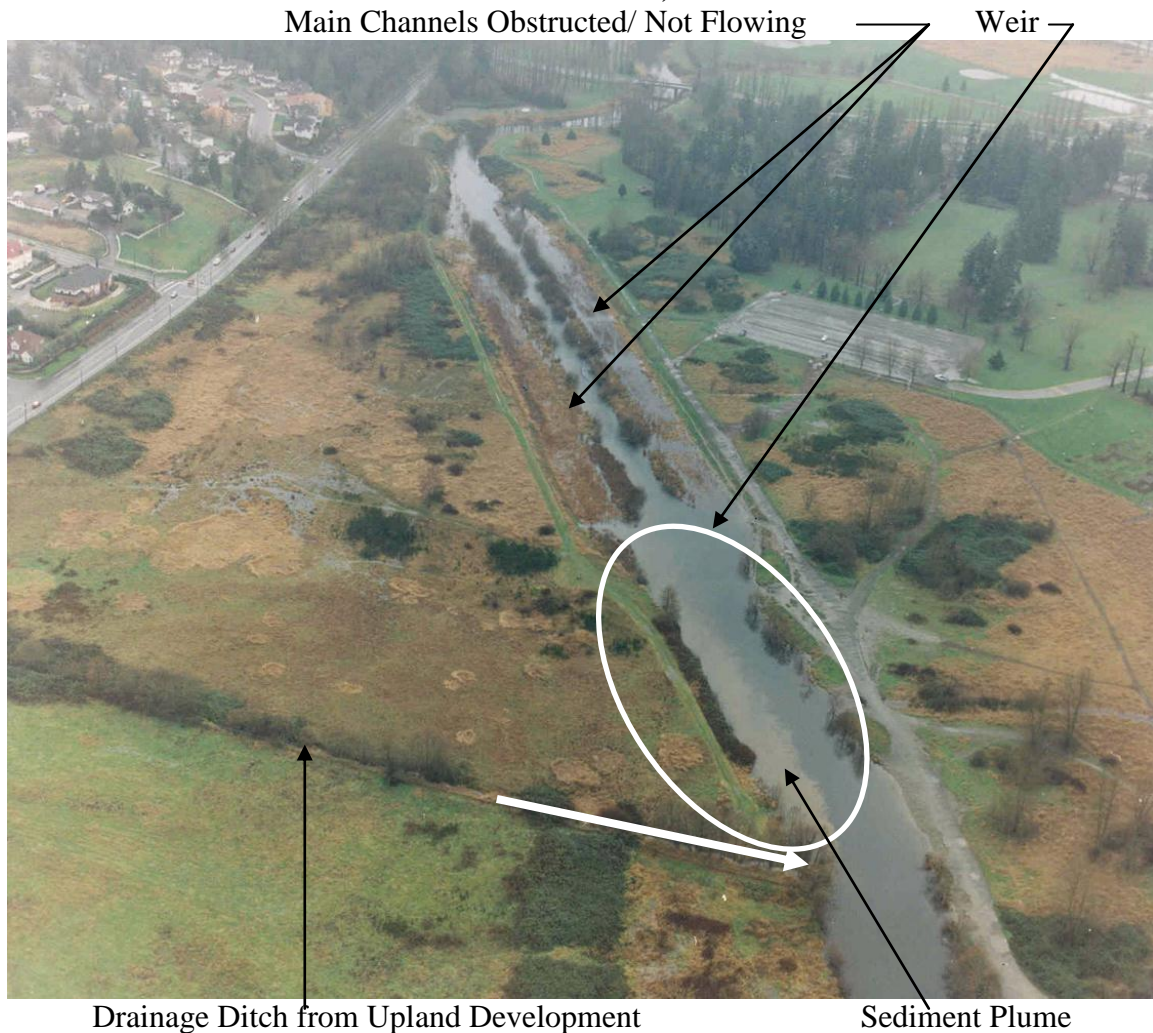
In addition, one or more drainage ditches dump storm water to the river ahead of the weir. The following photo, from a 2007 County document, clearly depicts this issue. A plume of sediment is readily discernible in this photo. It is likely that significant amounts of sediment have accumulated in the river bed, again reducing the cross section available to flow.

### **Sammamish River Transition Zone, 2007 Flood Conditions**

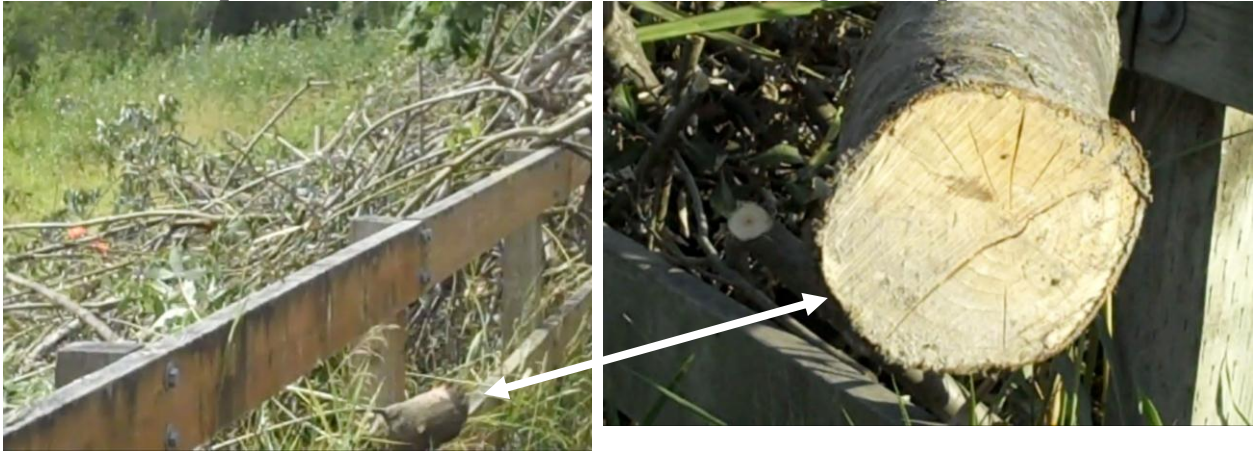
The addition of vegetation has been allowed along the edges of the center, low-flow channel. Unfortunately these fast growing plants impede flow. Obviously present for some time, their effect will have been a lowering the original design flow prescribed by the Corps of Engineers. As shown in the following photo of recently extracted growth, in just a few years, willows can grow to a diameter of 6 inches or more. With an extensive root structure, willows will act as a net capturing passing debris, further diminishing flow. Subsequent photos attest to this impact.

### Example Willow Growth Removed from TZ – August – Sept. 2011

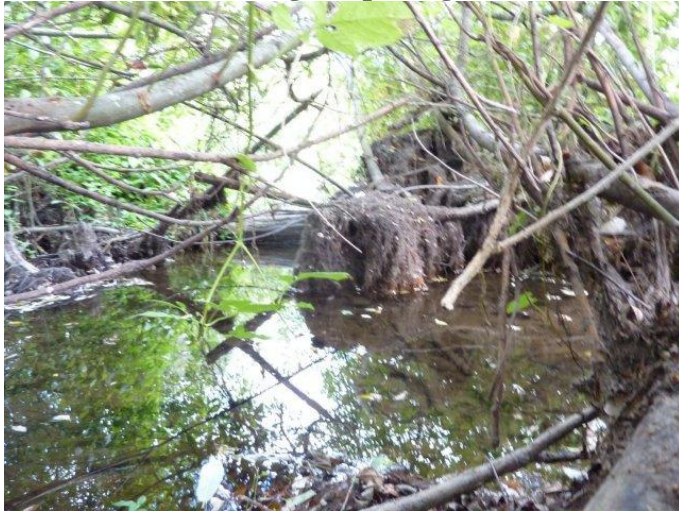
**Willow Snags Impeding Flow**

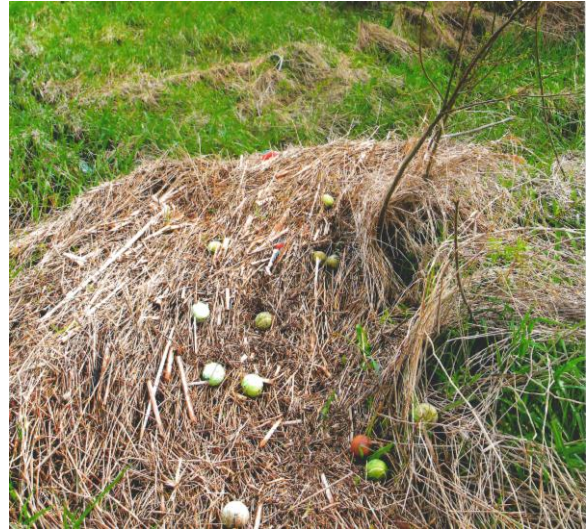
**Main Channel Debris Build-up**

The main flow channels sit considerably above the center, low-flow channel and the surface of the weir. While crews were observed working to remove cuttings from brushing this season, this has not been the practice for nearly a decade. As a result, debris has accumulated and raised the level of the main channels by several feet.

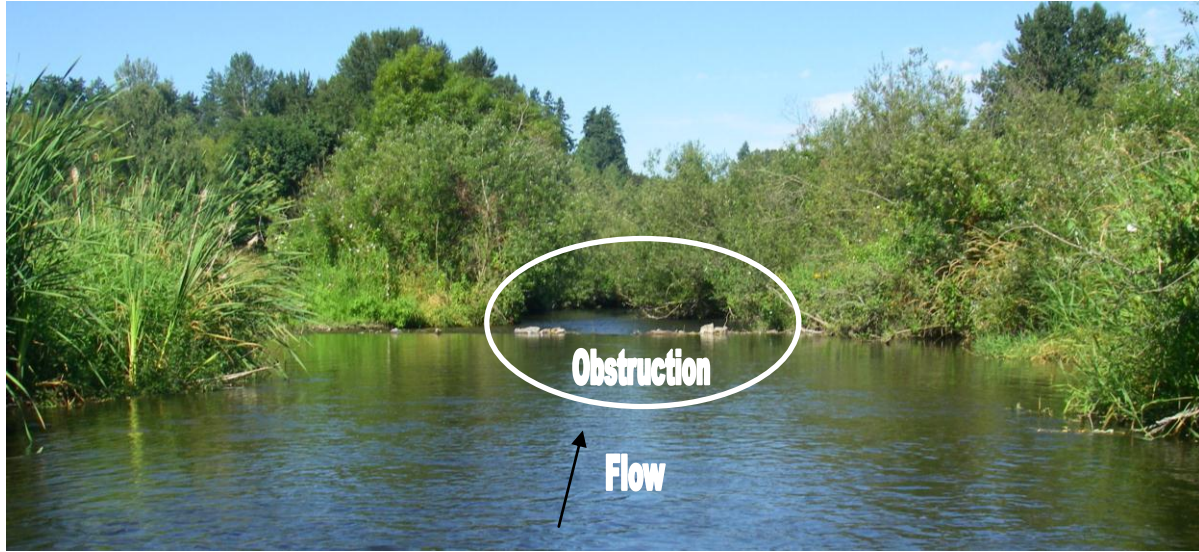
A rock obstruction was noted in the center, low-flow channel during the field visit. Shown in the following County photo, it too impedes flow. This is demonstrated by the pooling of water upstream of the obstruction. Placement of anything that blocks the flow of the active floodway (especially in-water placement) is typically prohibited without permits and a NMFS determination<sup>1</sup>. It is unclear who placed the rocks or why the rocks were placed in the water of the Sammamish River (in the bed of the active channel) or what permits were issued to allow this placement. This will impact channel flow and ultimately the water levels of Lake Sammamish. This rock obstruction will also impact the navigability of the river. If allowed to remain, it will pose safety risks to unsuspecting boaters.

The impacts of the obstruction can also be subtle. As noted in the photo below, and can be seen in aerial photos of the channel, the channel itself has been altered as water flowing through the area has sought out and cut new routes in the channel embankment. Such irregularities are much less efficient at moving flow. Discussion with County staff reveals the rock used for this small dam may be from the quarry spalls installed by the Corps' original project. Thus, the channel bed may have been compromised.

## Low Flow Channel Rock Obstruction – Sept. 2011

The County has performed the first of several actions promised to lake residents in April 2011. The main flow channels have been cut and raked and the center low flow channel willows have been trimmed. This trimming revealed a small dam of rocks which, according to WDFW may have existed since 2005. It should be removed.

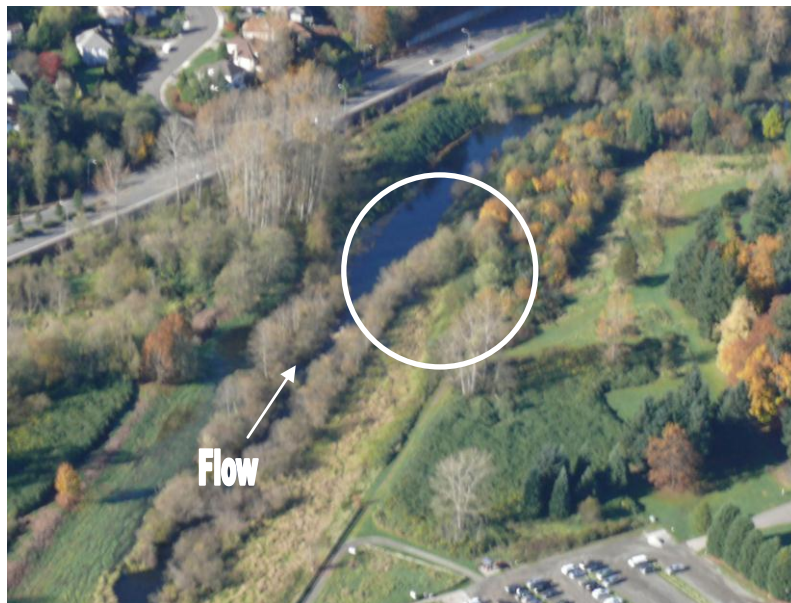
Further restrictions to flow in the main channels were observed. Trees and restrictive embankments can be observed at the north end of the transition zone. The first photo following identifies this location specifically. The second photo, taken recently, shows at least one large tree at this location. In addition, instead of the high flow channel transitioning smoothly to realign with the river, it actually rises several more feet. Such “pinch points” will present yet another impediment to flow and further increase flood risk to Lake Sammamish shorelines.

### North End of Transition Zone – Nov. 2010 (Showing Channel Constriction)

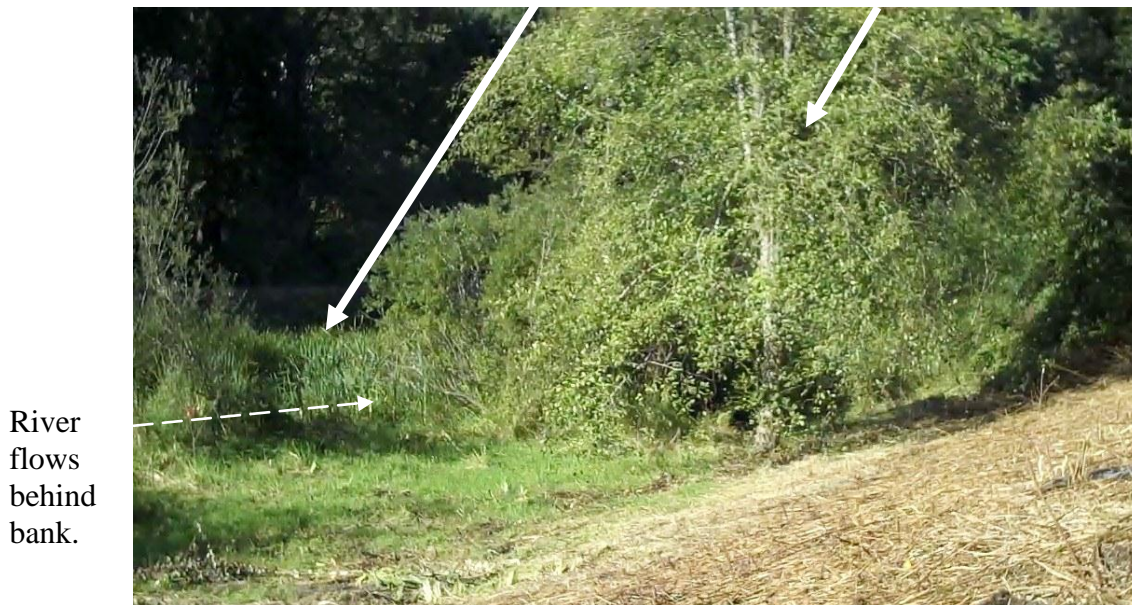
**North End of Transition Zone, East Bank Looking North – Sept. 2011**  
(Showing bank obstructions and tree in channel)
