## Summary of Actionable Elements for TZ Maintenance

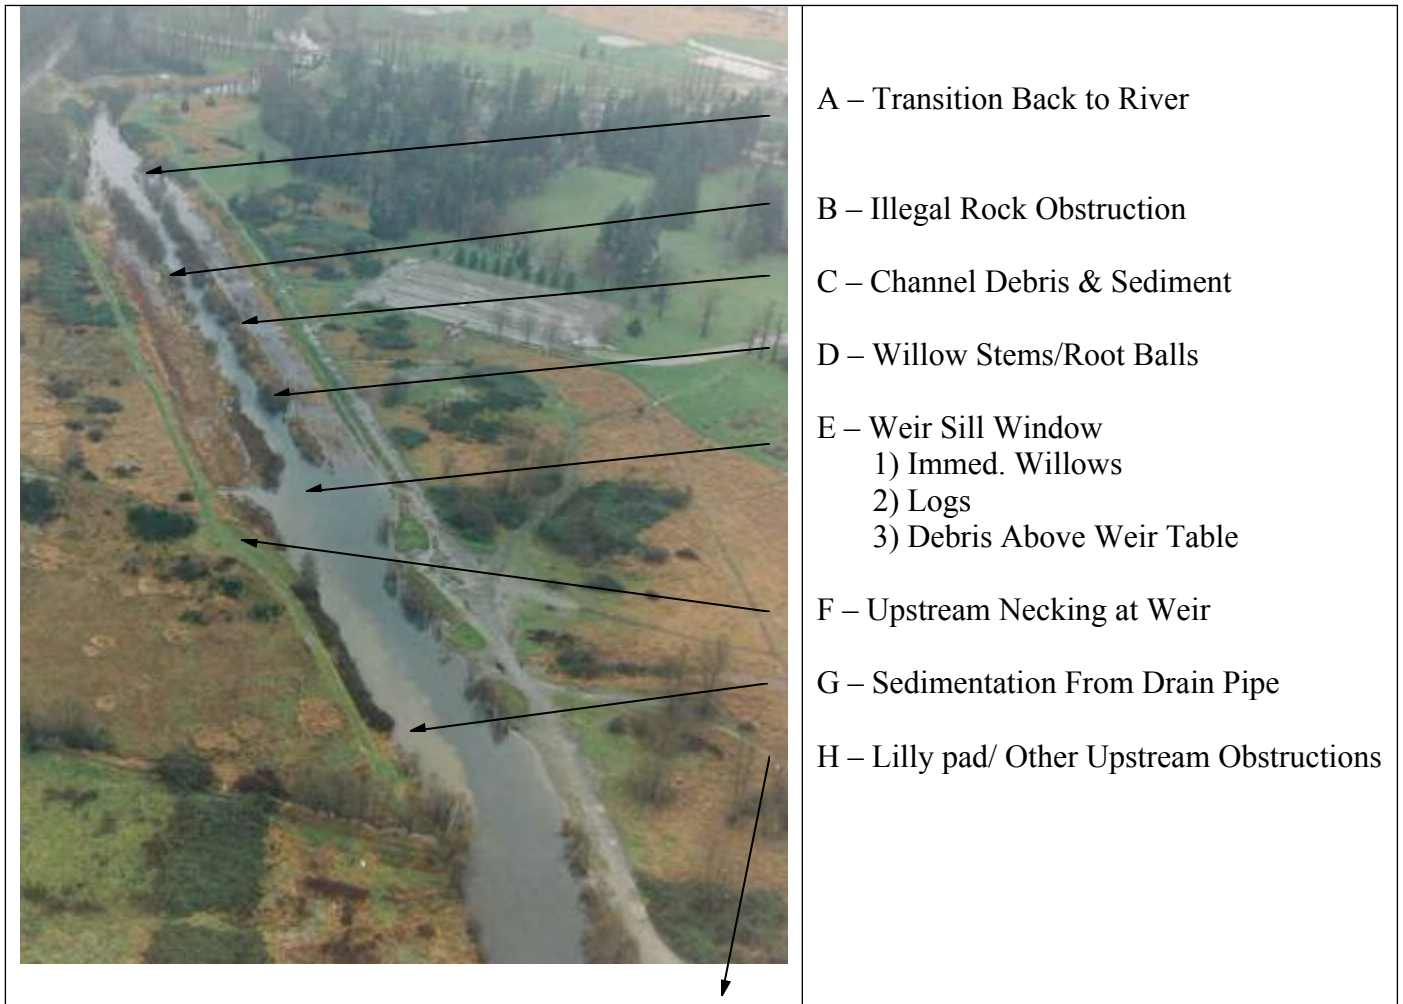
**A – Transition Back to River** – Essentially there are 3 channels that must merge back to the main river at the terminus of the TZ. Presently the outside channels terminate prematurely because this area is somewhat backwatered and materials carried in the stronger flow further toward the weir “fall out” in this area. Maintenance of this return area has not occurred.

**B – Illegal Rock Obstruction** – Discovered last fall during cutting and reopening of the center channel for navigability, this obstruction presents both a blockage to flow and a hazard to the public. For both reasons it should be removed.

**C – Channel Debris & Sediment** – Most individuals consider the maintenance action to clear the side channels as the primary task for maintenance. Certainly the presence of half a foot of sediment build-up will have an effect. There may be debris atop this sediment, as well. Returning these high flow channels to the quarry spalls lining the channel may not be possible, but some feasible action needs to be identified.

D – Willow Stems/Root Balls – The high flow channels, for the most part, are relatively clear but are covered by Reed Canary Grass, an invasive. Closer to the center, low flow channel will be found mounds of root balls and stems of willows left as part of the clearing operation. This creates a major impediment to flow and, technically, given the agreed width of the willows is only 10 ft., should be removed.

E – Weir Sill Window – The weir was designed for flow to occur across its entire width AND with the expectation that below it would be a window through which the passing waters could easily flow. This condition has been obliterated.

- 1) Immed. Willows – immediately below the weir are willows which might be pulled back 100 ft.
- 2) Logs and debris have been allowed to accumulate in this same area, altering the original design.
- 3) Debris Above Weir Table – while related to the above, the objective should be to assure that nothing below the weir extends above the table (or elevation) established by the weir itself.

F – Upstream Necking at Weir – As noted in E, above, the original design called for a flare in the river to allow the full width of the weir to pass water. Cattails and other growth have been allowed to establish themselves and reduce the width of the window passing water. These should be removed and a smooth transition to a wider window reestablished.

G – Sedimentation From Drain Pipe – Sediment build up in the river leading to the weir may be affecting flow. Actions to evaluate remediation should be identified, evaluated, and included as appropriate. Certainly long term monitoring is appropriate.

H – Lilly pad/ Other Upstream Obstructions – Further toward the mouth of the lake will be found infestations of lily pads and other obstructions to flow. Since slowing the rate of flow in the river will result in an increase its temperature, and this is detrimental to juvenile fish, action here may also be appropriate.
