TO: Kate Akyuz, King County Willowmoor Project

FROM: Martin Nizlek, Lake Sammamish Resident

RE: Submission of Water Level Issue Photos

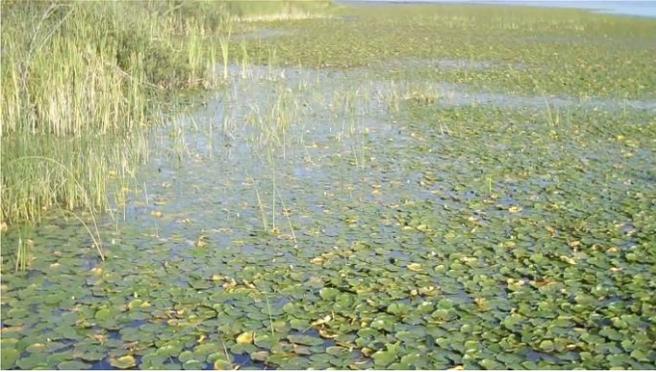
<p>1 - Lilly Pad Infestation River Head 2016</p>	<p>2 - 4" Diameter Willow from TZ 2010-2011</p>

The above photos show impediments to flow beginning at the mouth of the river at the north end of the lake. Infestations of lily pads, channel bank growth, and even cattails across a substantial portion of the weir deter flow. These may be the cause of the differential water elevations reported between water level gage readings at the weir versus on the lake.

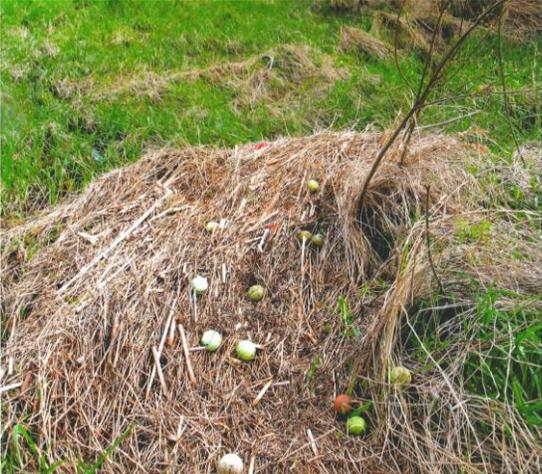
<p>3 - Brush Trimmings and Dog Balls 2011</p>	<p>4 - Cattail Infestation at Weir 2012</p>

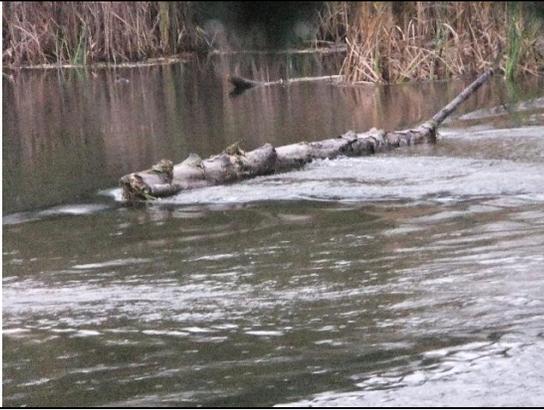
5 - Logs Blocking TZ Fall 2015

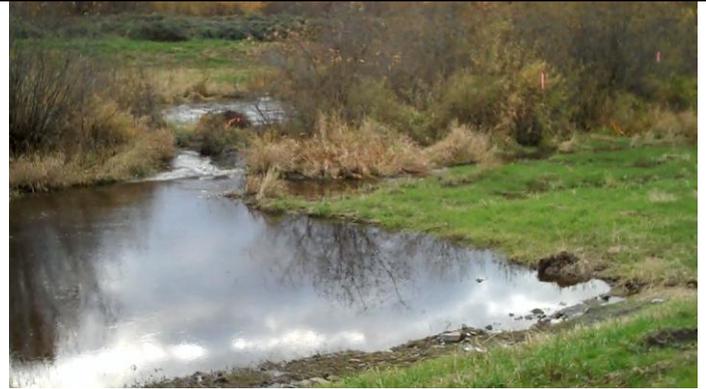
5a - Forced Divert TZ Post Sediment Removal 2013

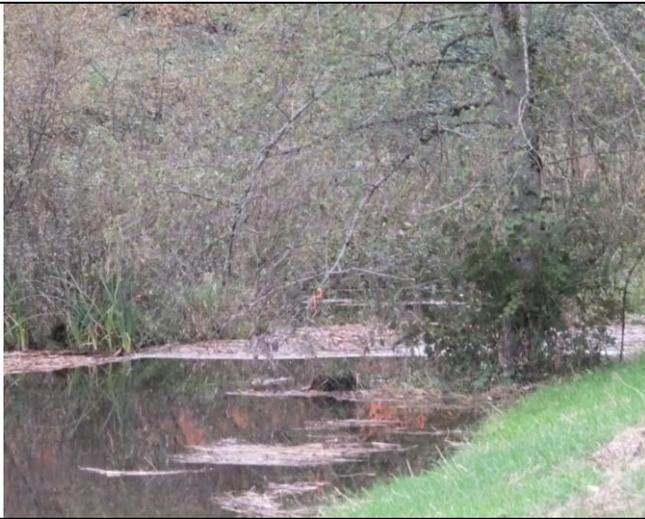
6 - Growth Remaining North End TZ 2014 & On

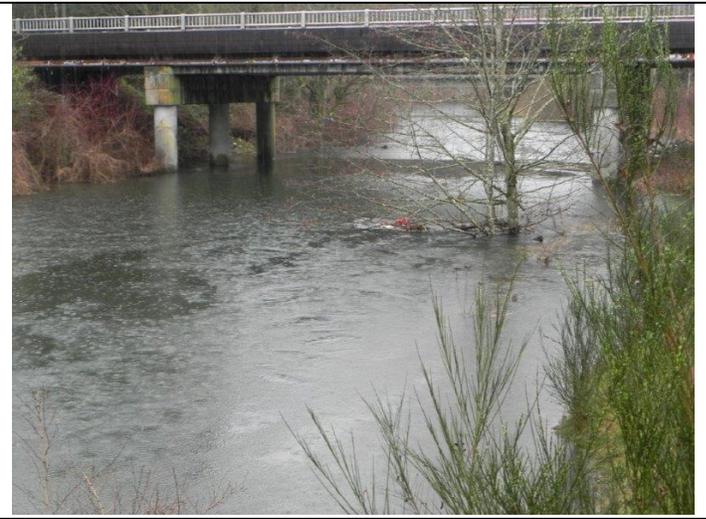
7 - River Blockage at Park Entrance 2014 & On

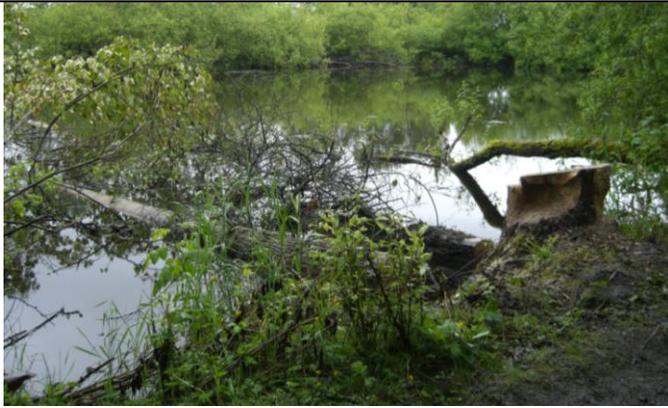
8 - Beaver Blockage Below TZ 2015

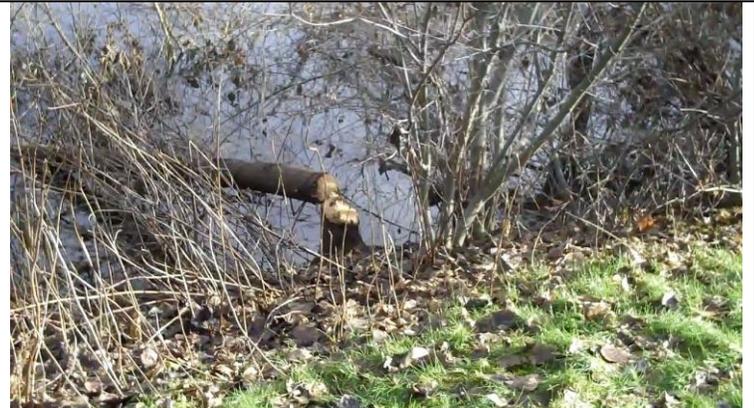
9 - Beaver Blockage Below TZ 2015

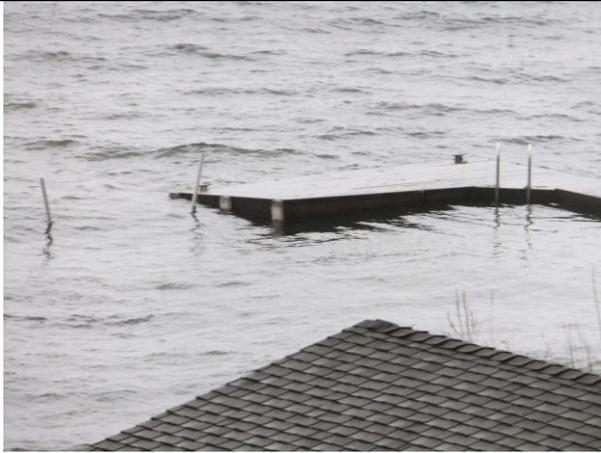
10 - Dock Piles "Popped" 2012

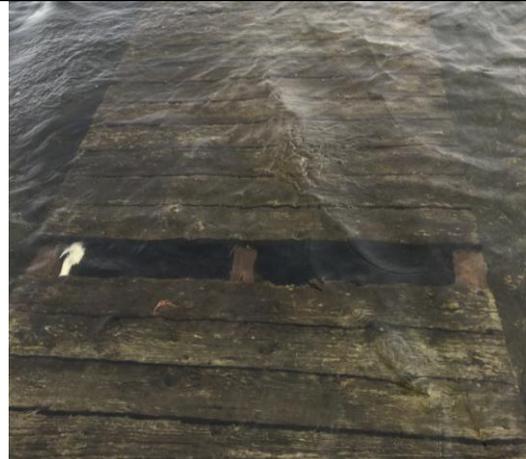
12 - Decking Submerged 2015

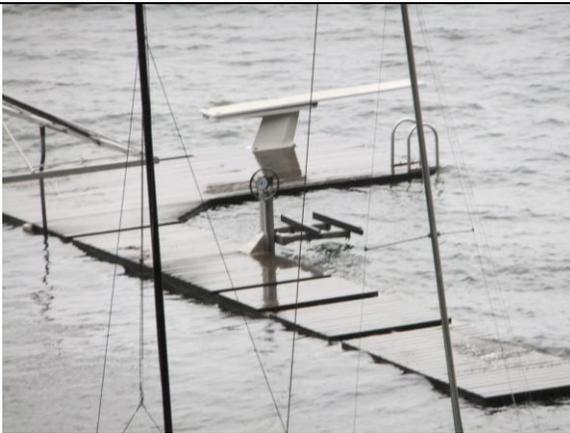
11 - Deck Destruction 2012

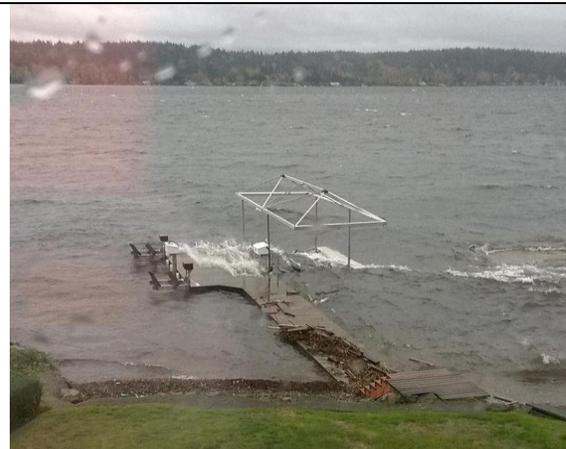
13 - Dock Destruction 2015

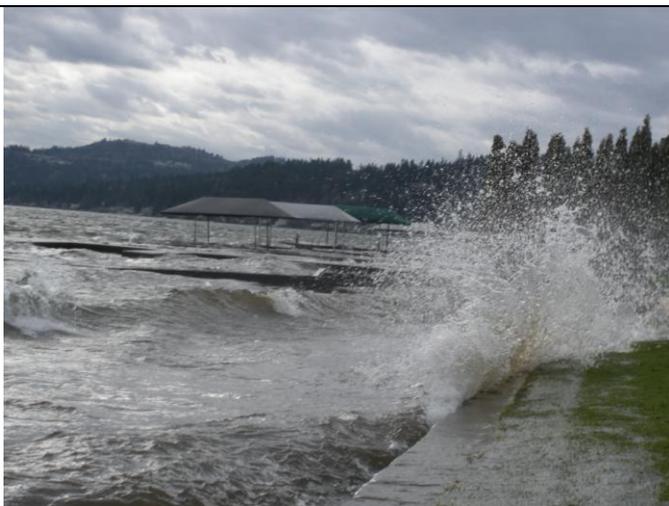
14 - Bulkhead Undermining 2011

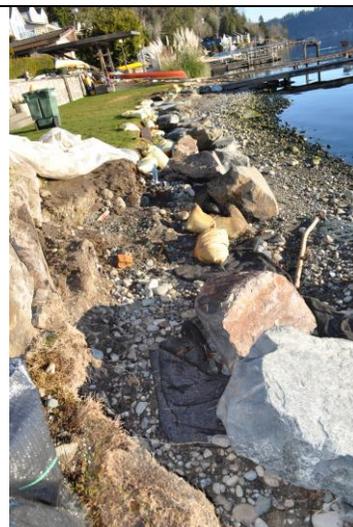
14a - Soft Stabilization Undermined 2016

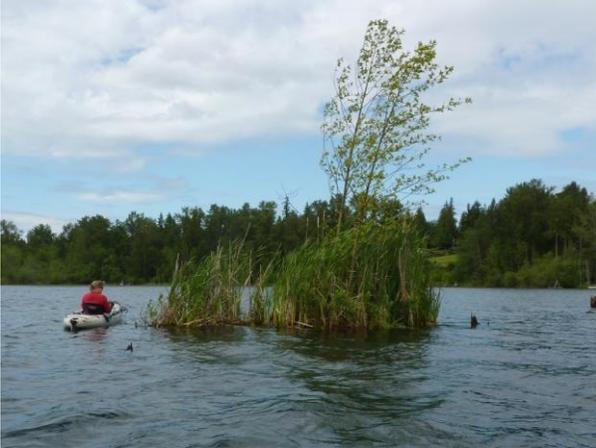
<p>15 - Major Erosion - Land Loss 2012</p>	<p>16 - Major Erosion - Land Loss 2012</p>

But, there are more subtle impacts. Loss of vegetation and erosion from extraordinarily high waters not only impacts lake water quality, but also diminishes shore accessibility and property value. Pictures 15 through 18 document these impacts.

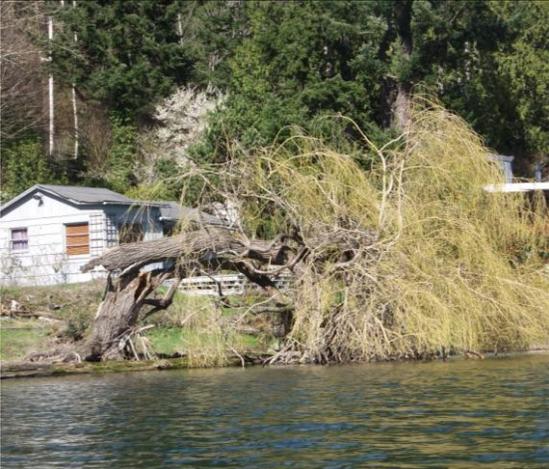
<p>17 - Shoreline Tree Loss 2014</p>	<p>18 - Benching Along Shoreline/Land Loss 2013</p>

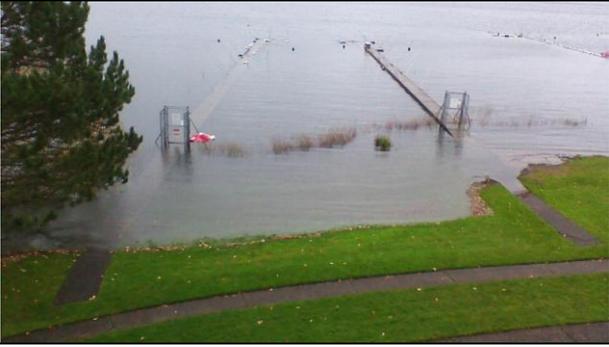
19 - Shore Inundation 2015

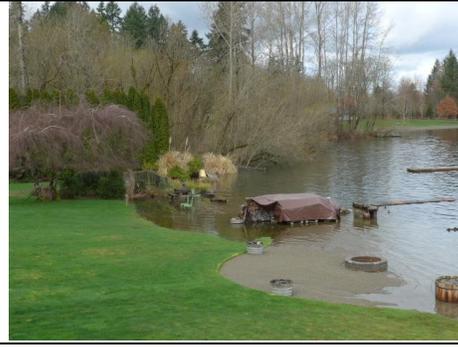
20 - Shore Inundation 2014

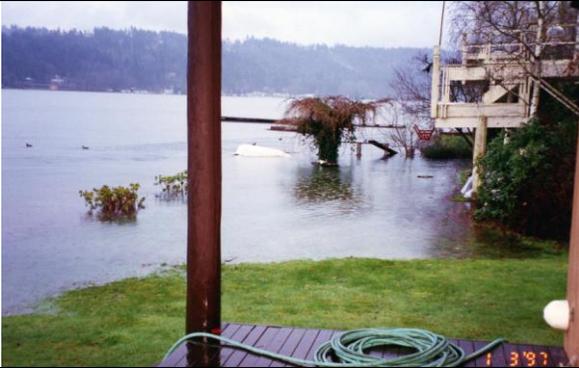
21 - Shore Inundation 1997

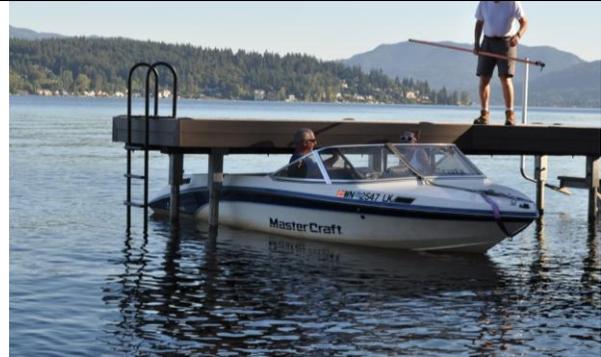
22 - Poorly Designed/ Dangerous Dock 2016

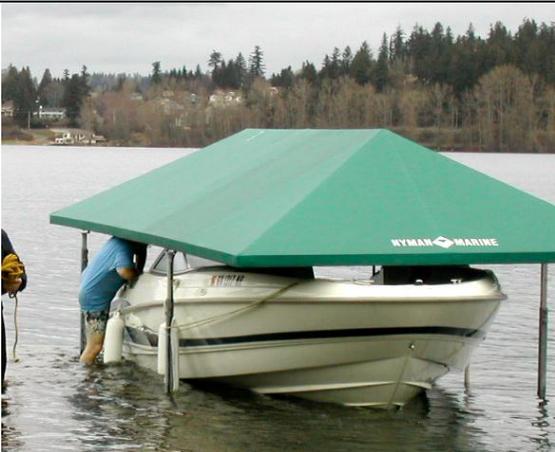
23 - Inaccessible Boating Conditions 2012

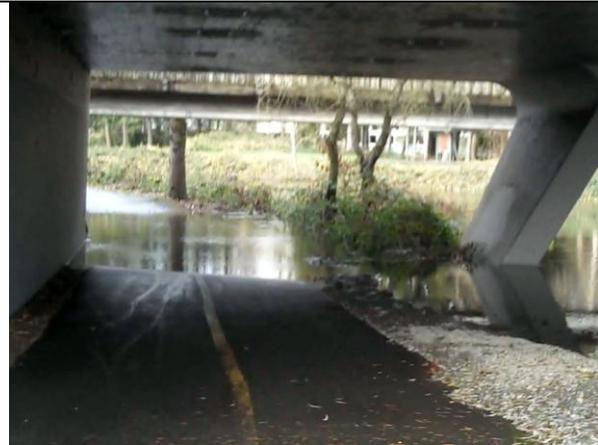
24 - Damage to Public Improvement 2015

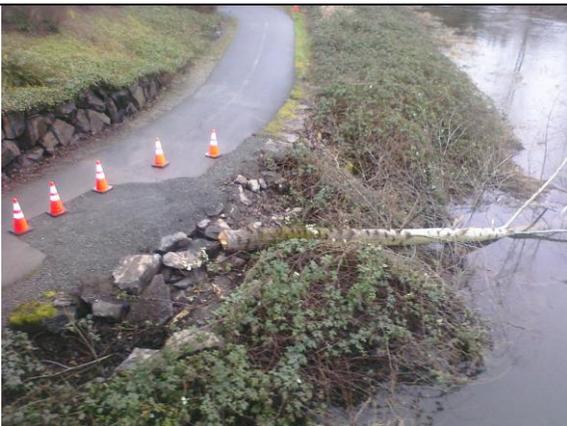
25 - Damage to Public Improvement 2010

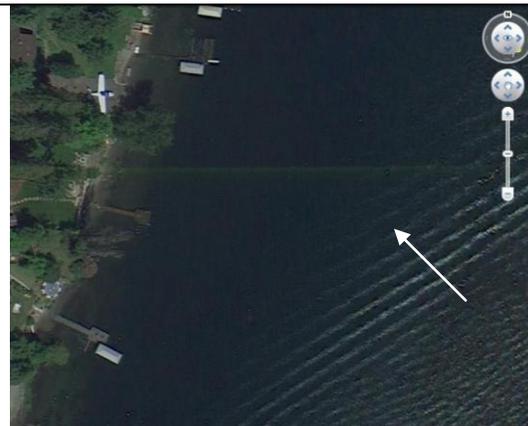
26 - Wave Fetch (SE to NW) 2010

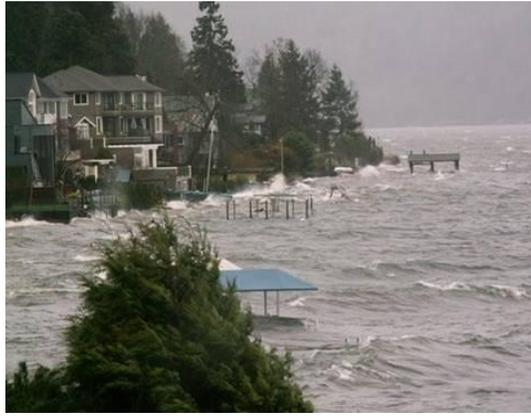
27 - Storm/Fetch Conditions SW Lake Samm. 1996
