Sept. 27, 2010

RE: Sammamish River Weir Visit

Following, you will find several topics with photos describing the situation at the weir and in the Transition Zone (TZ) which were of special focus during the site visit and actions to take as a result. In Appendix A, I have included a summary of the first meeting we had on August 19th. Appendix B provides a summary of a subsequent meeting citizens had with the Corps of Engineers.

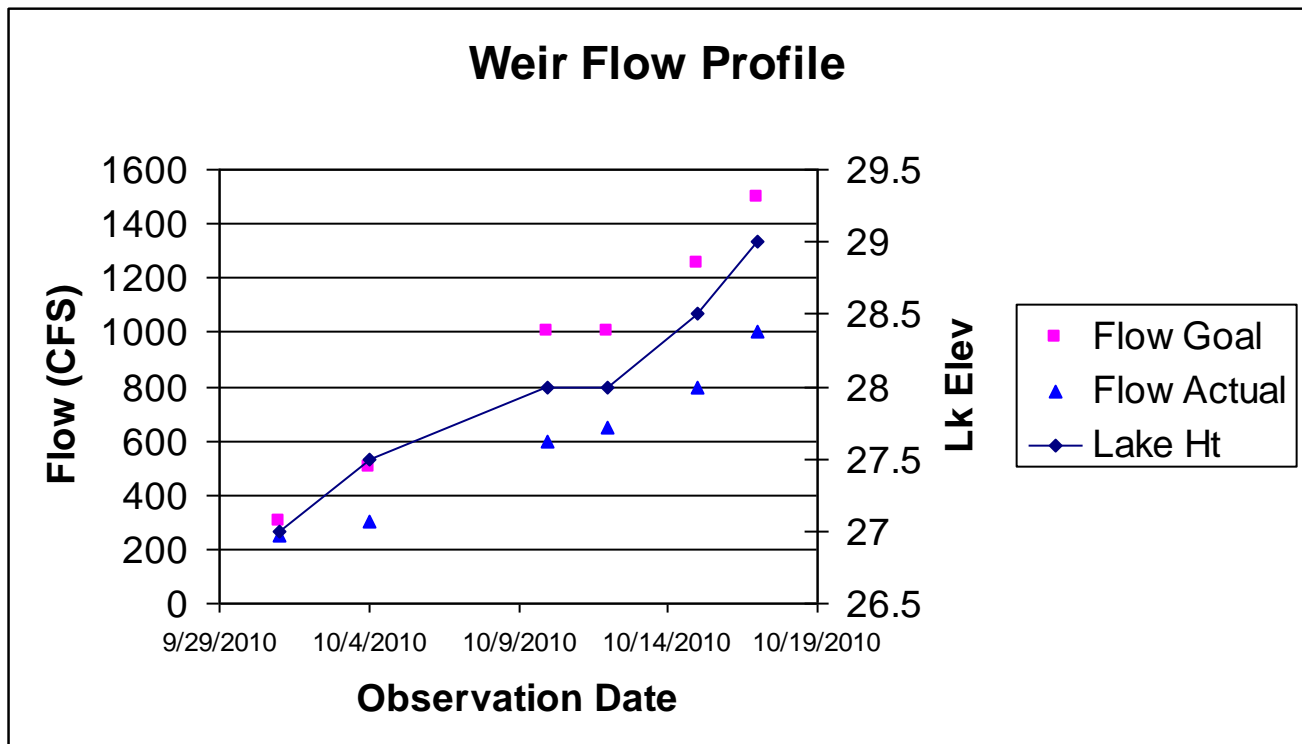
Proposed Monitoring Graph –

Data shown above is hypothetical. It shows both the lake level on each observation date (increasing from left to right), as well as two flow rates – the observed value (Flow Actual) and what is needed (Flow Goal). As an example, on 10/18 the lake elevation is shown at 29 feet. Actual flow was at only 1000

CFS, but the flow goal, as shown, is 1500. When actual flow is less than the flow goal, remedial action plans (yet to be defined) should be activated, conditions at the weir inspected and corrected, and citizens alerted to flood conditions.

Following is an example of information that should be monitored by the County with an action plan in place should constrained flow conditions be detected. Early action will avoid losses such as witnessed last spring... or worse.

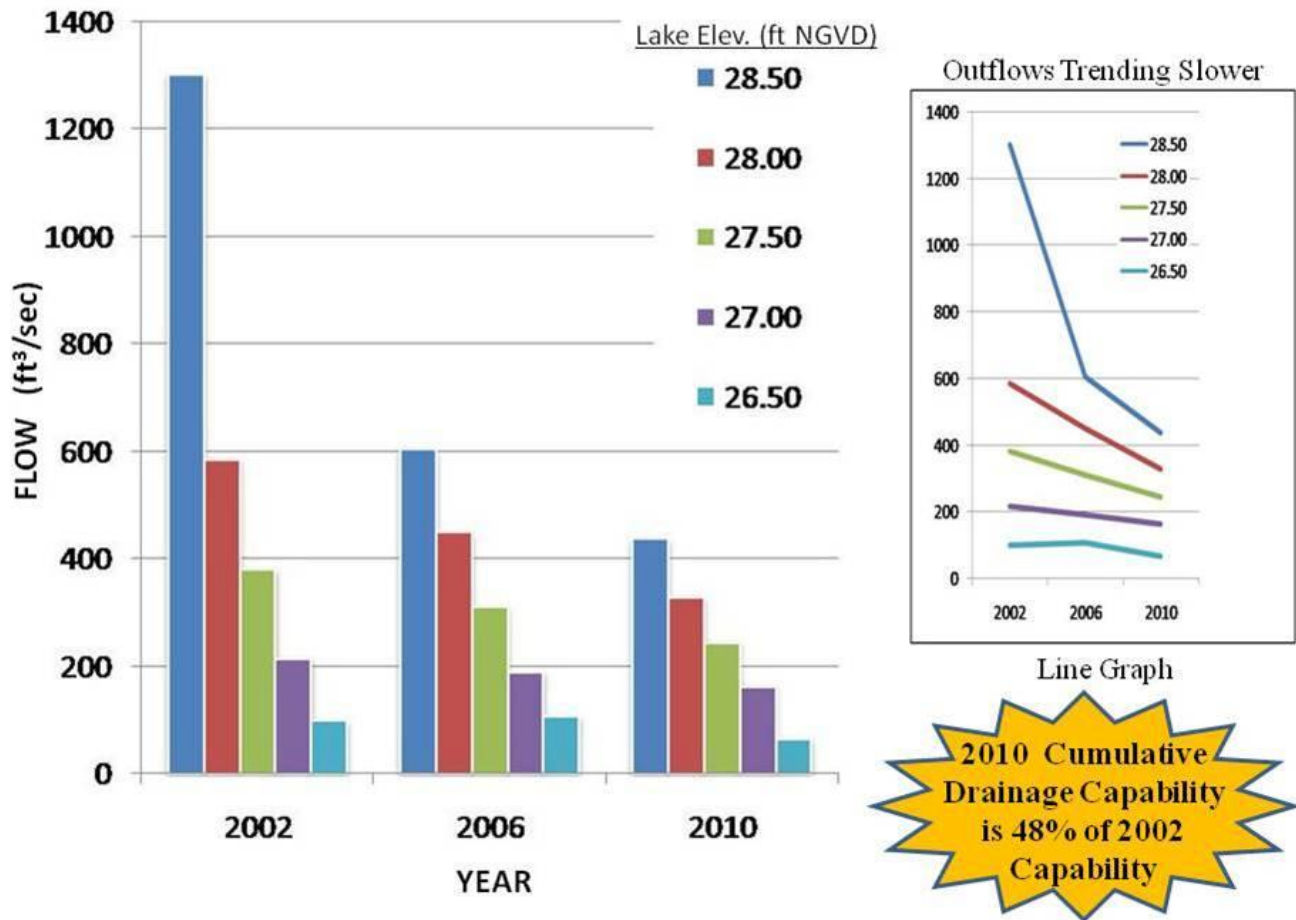
SUMMARY GRAPH: Lake Sammamish Annual Outflow Averages @ Weir

The resident engineers' analysis, accompanied by photographs, described the deterioration in flow conditions over a period of 8 years. Key among the findings of the analysis is the following graph showing the reduction in flow at all lake levels.

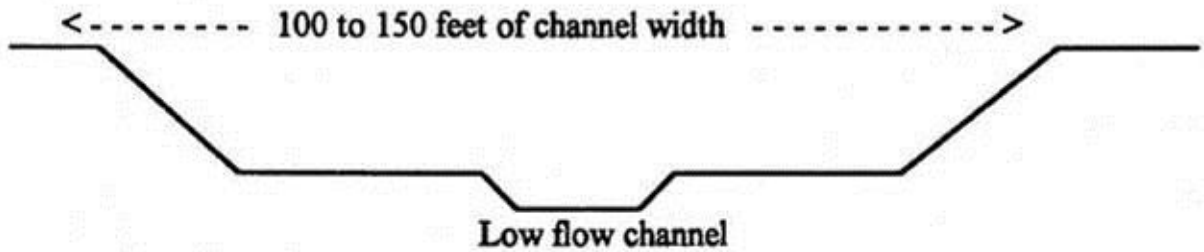
- Below is a schematic cross section in elevation view through the transition section. The low-flow conveyance section is in the middle. The low-flow section is lined and stays clear of vegetation. Vegetation immediately adjacent to the low-flow channel has been allowed to accumulate to provide some shade on the channel. The existing condition of the left and right sections is complete cover of vegetation grown to a height of 10 to 15 feet.

--- Designed capacity is to pass 1,500 cfs at a water surface elevation of 29 feet. ---

Failure to maintain the transition zone to these standards has led to artificial and persistently high lake water levels, the consequences of which were presented by residents. Some of their pictures are shown here.

- The existing condition is not expected to persist into the future. The Corps is recommending that the left and right conveyance sections be trimmed to a height no greater than 6 inches every 2 years.
