## Field Review of Sammamish River Weir & Transition Zone – September 2011

Martin Nizlek, Ph.D. Civil Eng.

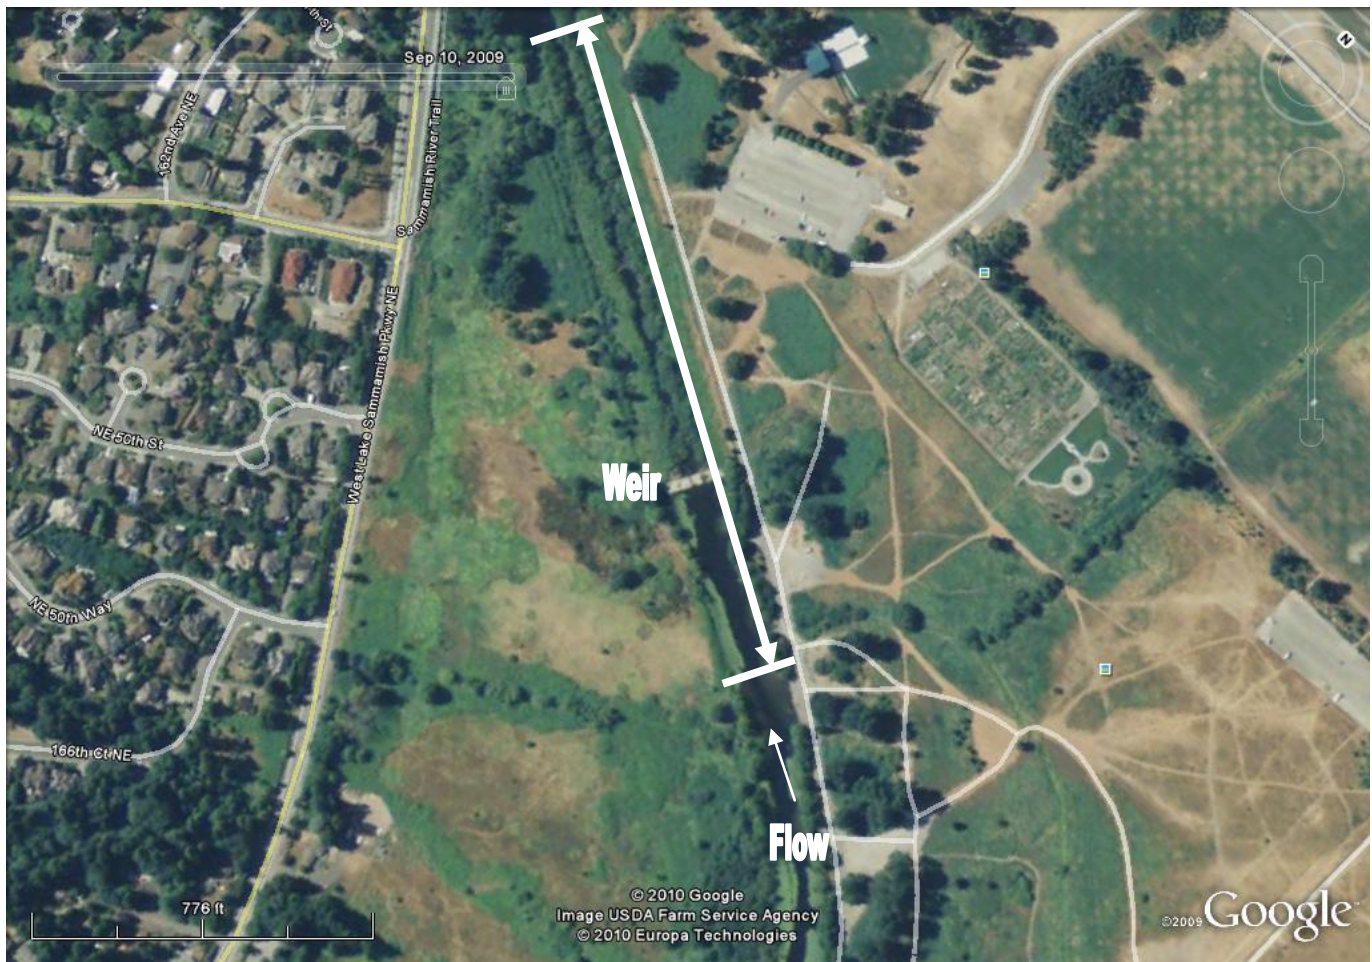
Observations were made from atop the east channel bank in the off-leash dog area of the park extending from several hundred yards upstream (lake-ward) of the weir some 1600 feet to the north end of the transition zone prior to its terminus as shown in the following photo.
